LOWER SNAKE RIVER LITTLE GOOSE AND LOWER GRANITE LOCKS AND DAMS

**Adult Fishway Systems
Emergency Auxiliary Water Supply
Phase II – Technical Report**

Final Report

September 2000

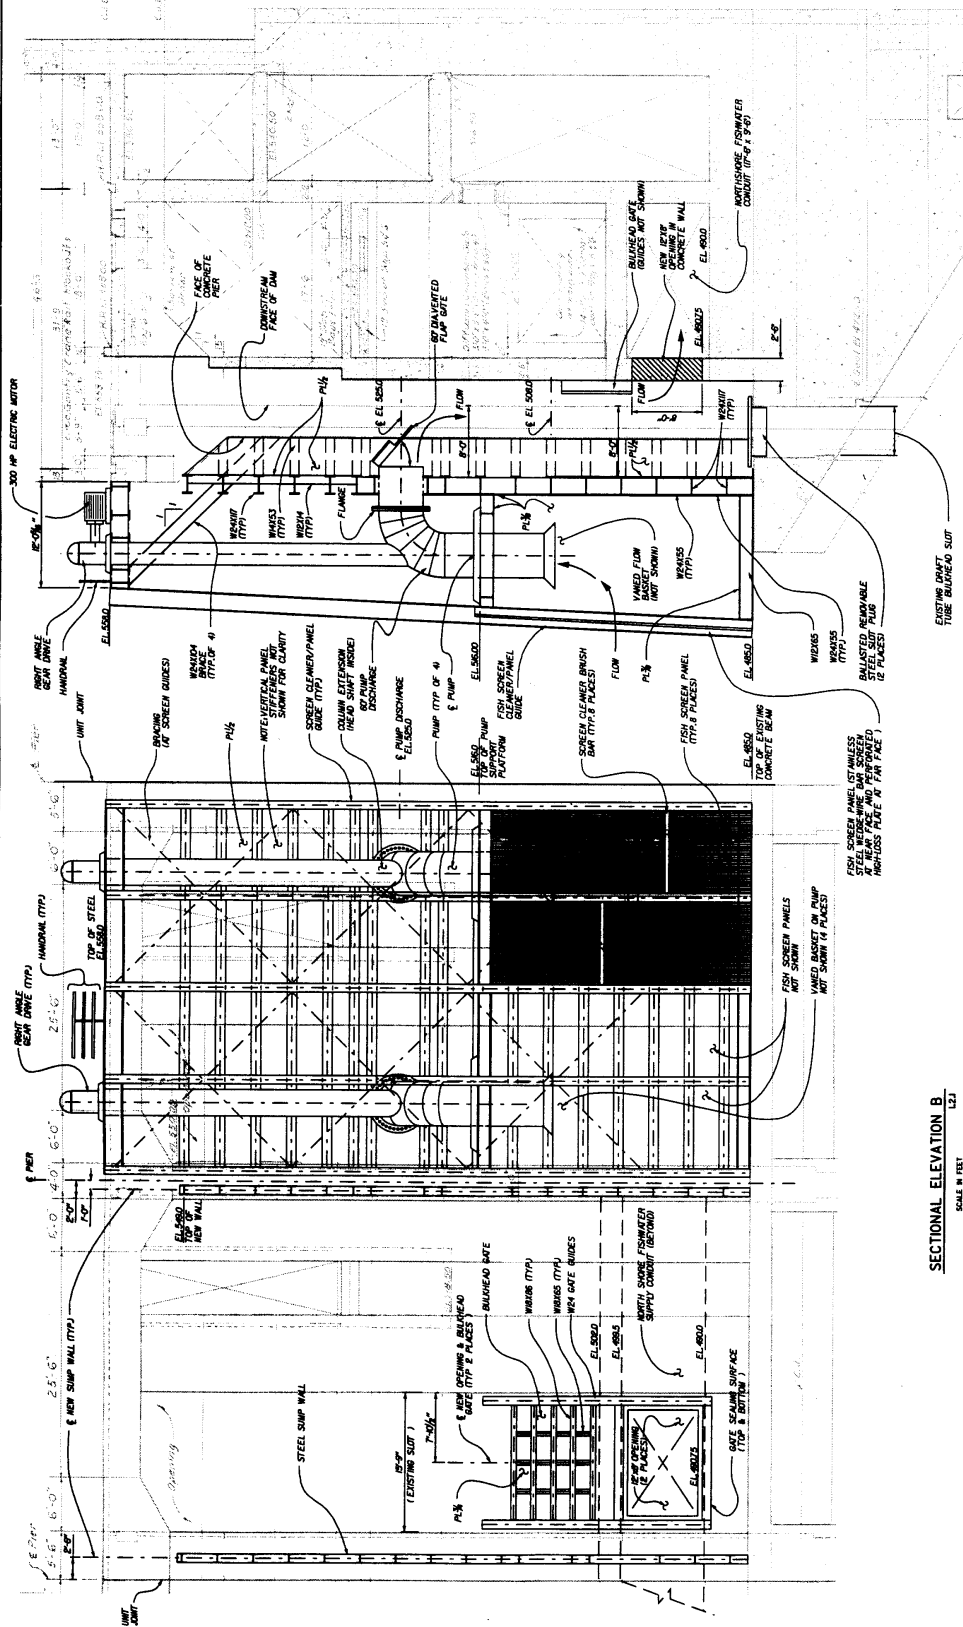
PLATE 1.2.2

SECTIONAL ELEVATION B

SECTION A

17	Plate 1.2.2	In report section 4.5.3.4.b, first paragraph, installation of each pump structure as a single piece is described. Section A of Plate 1.2.2 should depict more specific structural continuity, between the deck level support and the lower structure, if the structure is to be transported and installed as a unit.	A - I think that your Comment No. 7 is valid. The text will be revised to indicate that construction installation would be accomplished with components bolted together at the site.	C	KBF
18	Plate 1.2.2	Section A: Attaching to the midspan of the crane rail beam may apply forces in excess of available capacity. A more substantial structure may be necessary to span across the entire opening without using the crane rail beam for support.	A - I agree. The crane beam may have reserve capacity, however, it would be prudent to span the 42' rather than attach to the beam. We will review this in the design.	C	KBF

4.	Plate 1.2.2	1. It looks like it may be difficult to get the draft tube bulkheads in the slots behind the pumps. Is their adequate clearance? 2. How does the steel plug in the bulkhead slot get removed if a bulkhead needs to be installed? 3. How is the steel structure protected from corrosion?	A - The design is intended to provide a clear path for bulkheads, roughly defined by the width of the slot opening in the concrete roof of the draft tube discharge. This should be possible with the configuration shown. Note that the flap gate which appears to protrude into this space would not protrude during the installation/removal of the bulkheads. The same mechanism/system that is used to retrieve the bulkheads (lifting beam on the crane and lifting eyes on the equipment) would be used. Should work the same way. Corrosion protection could be the COE's heavy duty paint system or a metalized coating system. Impressed current systems don't seem to be very successful over the long term.
